NACA RM No.SA7A07

NATIONAL ADVISORY COMMITTEE FOR AERONAUTICS RESEARCH MEMORANDUM

BUFFETING OF EXTERNAL FUEL TANKS AT HIGH SPEEDS

ON A GRUMMAN F7F-3 AIRPLANE

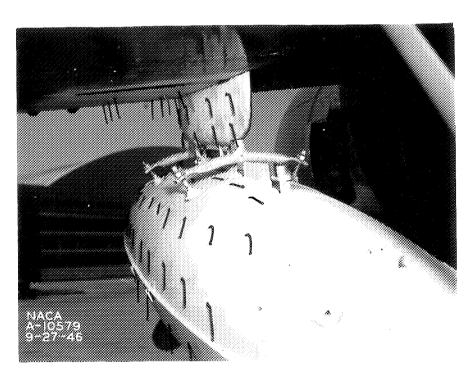
Figure 6.- Wing position, sway brace, configuration 4.

Effect of sway bracings - Comparison of the data for configurations 3 and 4 shows that the addition of the auxiliary braces increased the Mach number at which buffeting started by 0.077. It was noted previously that for configuration 4, the total preload was greater than for configuration 3. These results demonstrate the importance of adequate lateral bracing for the tanks. The original service configuration, which depends essentially on the rigidity of the central columns for lateral bracing, would appear from these results to be deficient in that regard.

Configuration 4.- Configuration 4 differs from configuration 3 only in its lateral rigidity. The flow characteristics are essentially the same as for configuration 3. Flow separation occurred at M≈0.60 but the tank shaking began at 0.529, while the tufts indicated severe turbulence or incipient separation. The shaking of configuration 4 before flow separation occurred was believed to be accentuated by the relatively low lateral rigidity of the installation.

- 4. Service-type sway brace (fig. 6)
 - (a) Round service-type sway braces
 - (b) Rubber removed from sway brace pads
 - (c) No auxiliary braces
 - (d) Adjustment screws torqued to exert 13,000 pounds per sway brace on tank
